**REPORT ON:  
143 WATERSHED ROAD SUBDIVISION**

**PROJECT:  
GEOTECHNICAL ASSESSMENT**

**CLIENT: LC BUILDERS LTD**

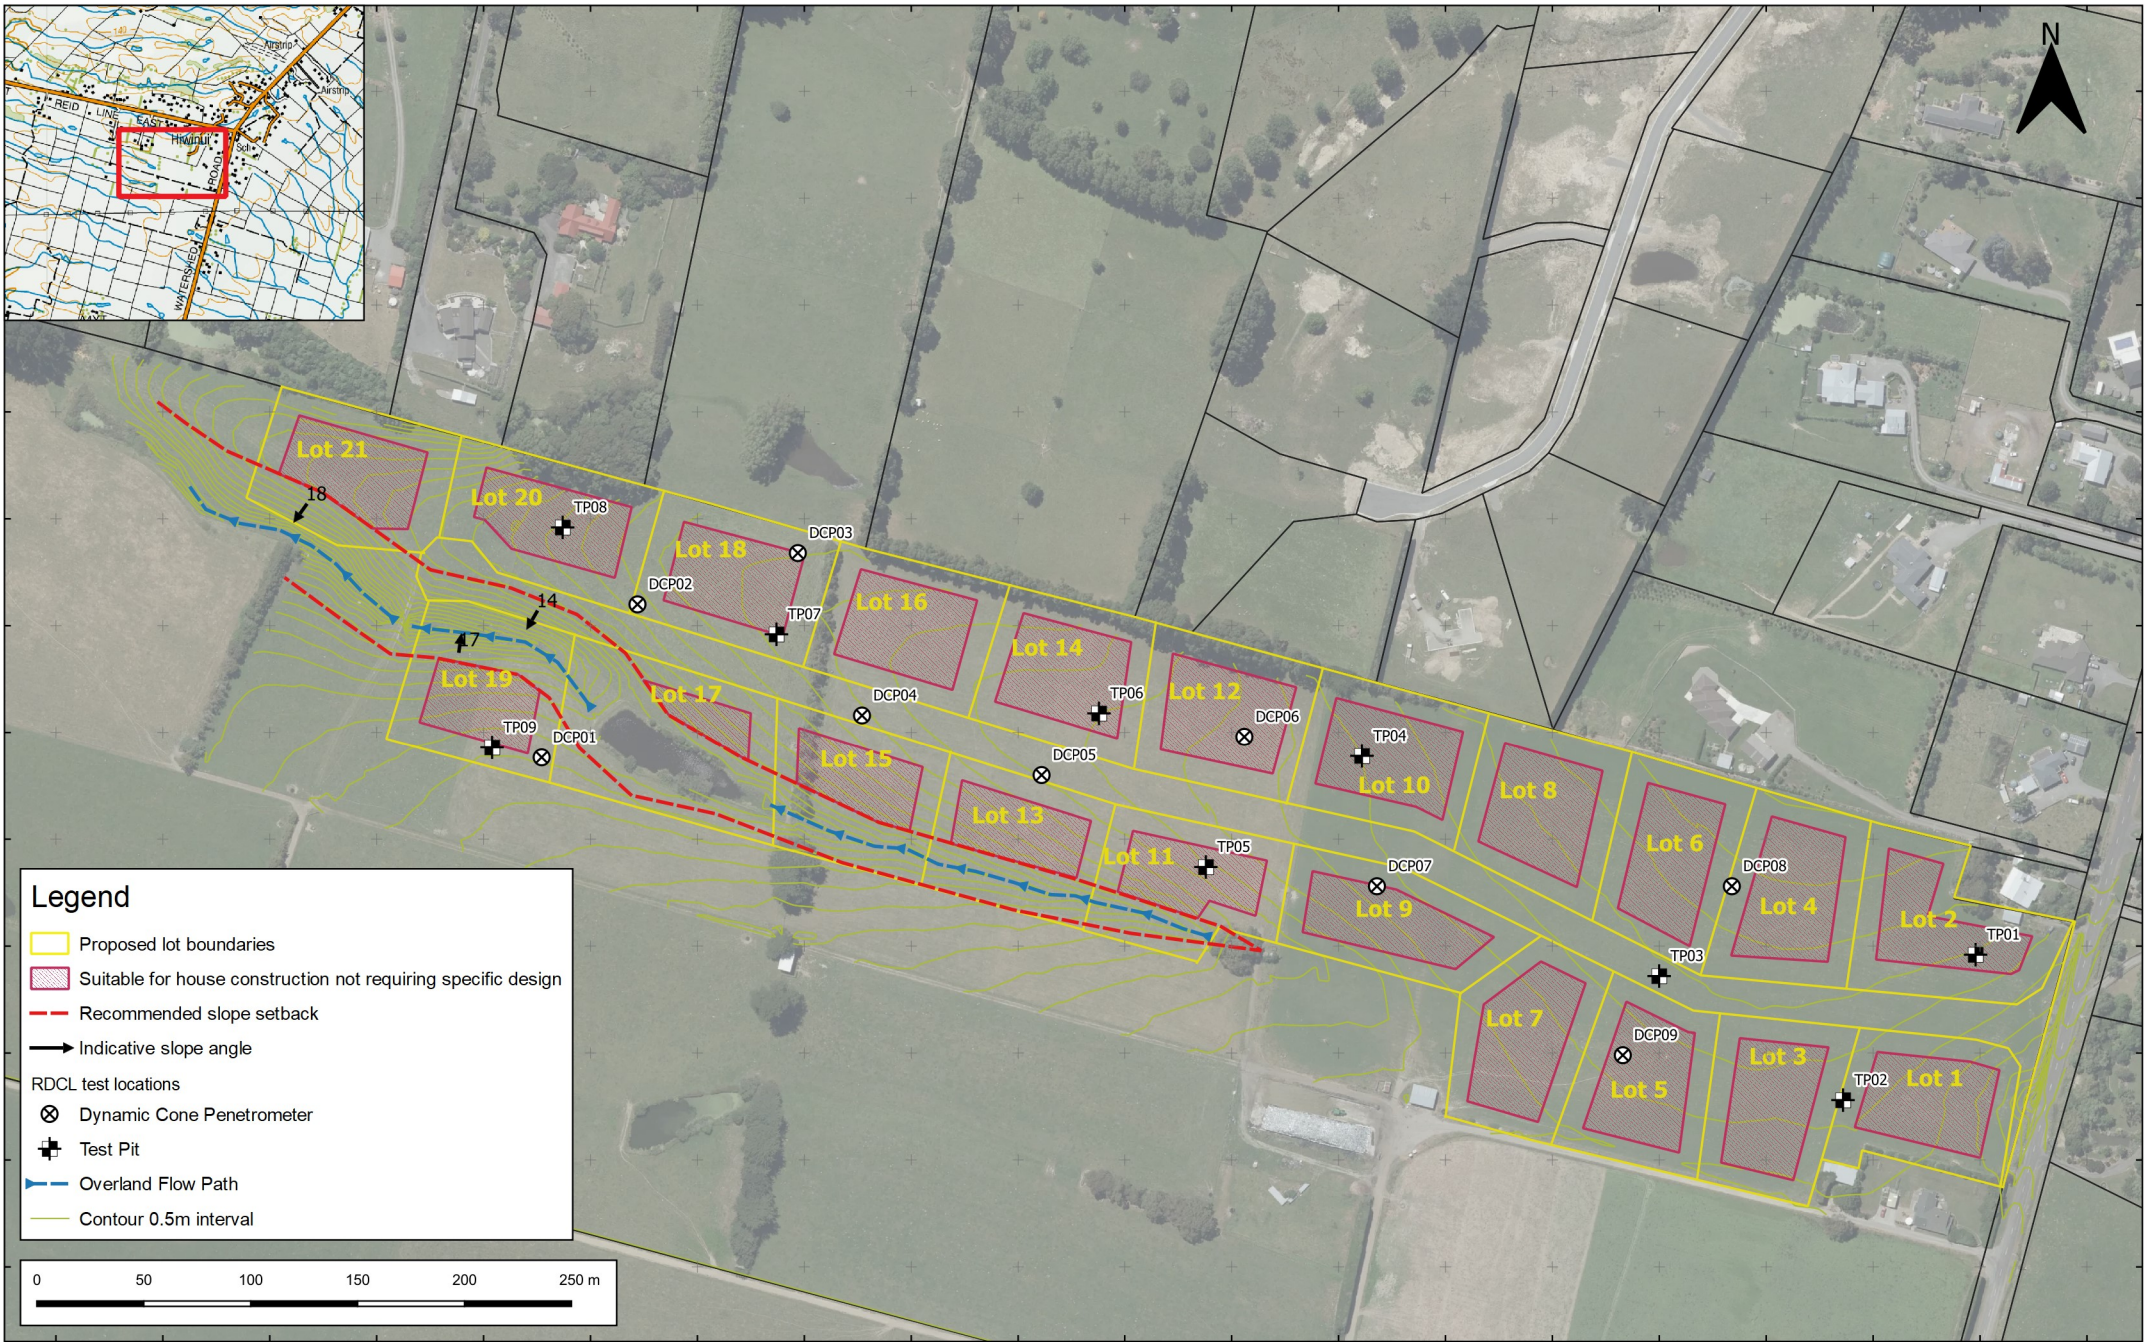
## FIGURES

**Legend**

- Proposed lot boundaries
  - Suitable for house construction not requiring specific design
  - Recommended slope setback
  - Indicative slope angle
- RDCL test locations
- ⊗ Dynamic Cone Penetrometer
  - + Test Pit
  - Overland Flow Path
  - Contour 0.5m interval

- To confirm bearing for specific foundations at the time of construction;
- To consult for detailed design of earthworks and/or foundations should construction be proposed outside of indicative house sites shown;
- Should ground conditions be found to differ from those contained in this report.
